# Manhole Inspection Summary

Manhole # S35Q\_\_075MH

Insp Date: **3/20/08 10:22 AM**

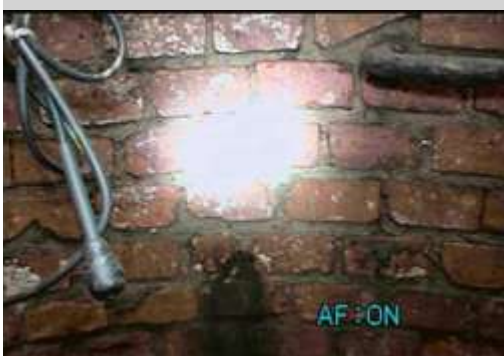
Defect 6

Infiltration: ☐ None ☐ Joint ☐ Cracks ☐ Mortar ☐ Roots ☒ **Wall**

Corbel infiltration

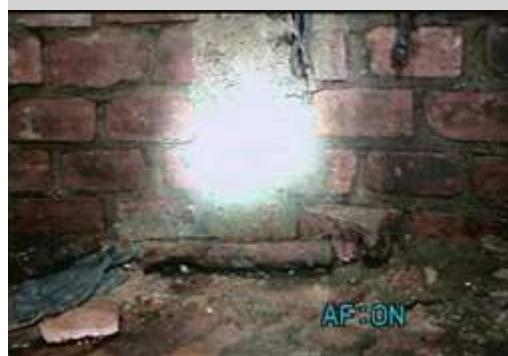
Defect 5

Condition: ☐ Sound ☐ Cracked ☐ Root Intrusion ☐ Deteriorated ☐ Leaks ☒ **Debris**

bench debris

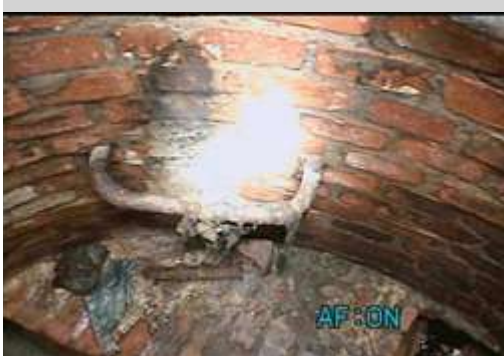
Defect 4

☒ **Evidence Of Surcharge** Depth: **2** (ft.) ☐ Active Surcharge Present

evidence of surcharge

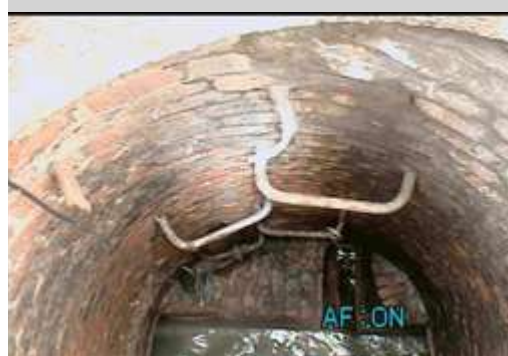
Defect 3

Count: **5** Missing: **1** ☒ **Corroded**

Corroded steps

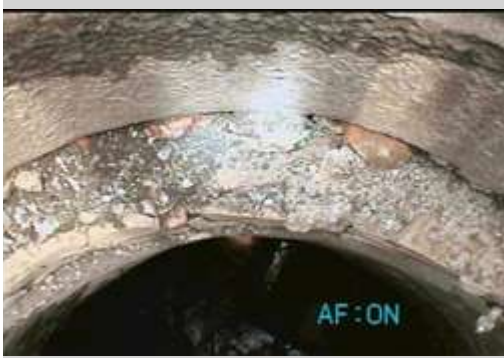
Defect 2

Offset: **3** (in.)

offset

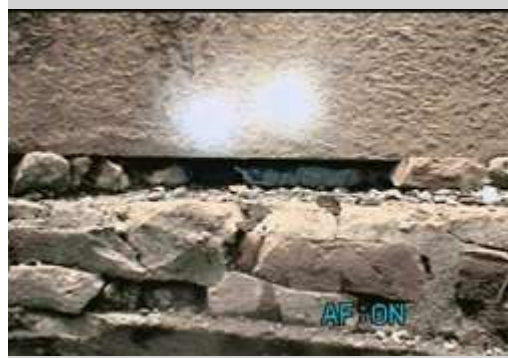
Defect 1

Condition: ☐ Sound ☒ **Cracked** ☐ Root Intrusion ☒ **Loose Brick** ☒ **Deteriorated**

chimney loose bricks,  
cracked,deteriorated,  
frame adj

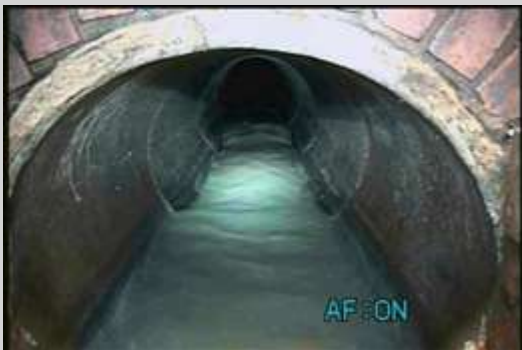
12 O'Clock Outflow

Deposits: ☐ None ☐ Mud ☒ **Sludge** ☐ Debris ☐ Grease

Silt Depth: 6 (in.) Deposits Extent: **Light**
